# Remote Sensing for Delineation of Breaches along the Embankments of Indus River during Flood 2010

Raheel Ahmad, SUPARCO

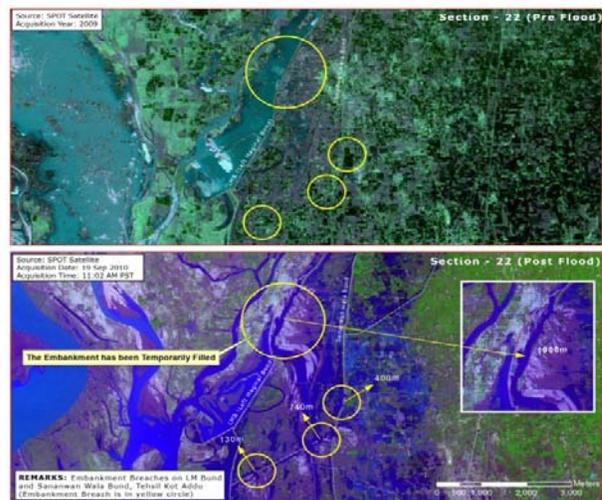
Figure 1.1 LMB Breach near Taunsa Barrage, Punjab

The delineation of breaches could be carried out by observing any high flow of flood water outside the embankments. Once a breach along the embankment or canal is identified, the length and status during pre and post flood situation is analyzed. The comparative analysis with a pre flood image gives the information about the condition of embankment before the flood. Assessment reveals 141 breaches all over the country among which 60 were delineated in Punjab while 76 in Sindh. Most of the breaches were byproducts of three main breaches that are Left Marginal Bund (LMB) in Punjab, Tori and Kot Almo in upper and lower Sindh respectively. Figure 1.1 shows the breach in LMB of Taunsa barrage which bursted and produced 1900 meter long breach. This breach created a lot of damage in Layyah, Bhakkar, and Muzaffargarh Districts. Several breaches formed as a consequence of LMB breach in adjacent bunds and canals particularly left bank canals (Muzaffargarh Canal, Taunsa-Punjadn Link Canal) of Taunsa barrage.

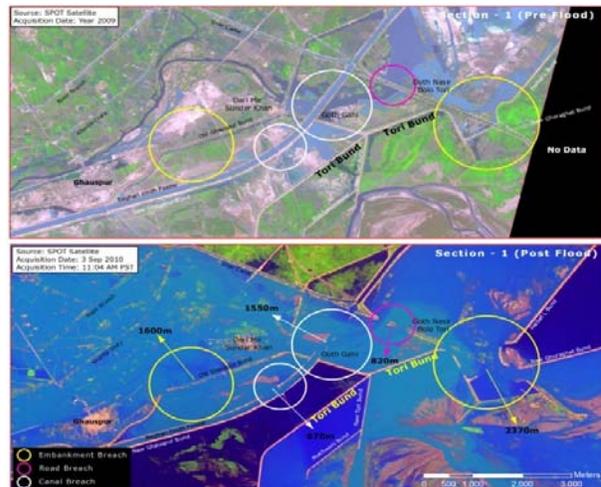
Figure 1.2 Tori Breach in Sindh

In Sindh, a breach which almost diverted the whole flow of water of the Indus River is Tori breach. Figure 1.2 shows the Tori breach on River Indus which caused multiple breaches in canals and roads. Tori breach resulted in vast destruction in the province particularly in Kashmore, Jacobabad, Qambar, Shahdadt and Dadu. The water flow on the right bank of

Indus is obvious because of the natural depressions in the north western part of Sindh. Tori breach resulted in producing number of breaches in canals and roads and caused a major loss of infrastructure.

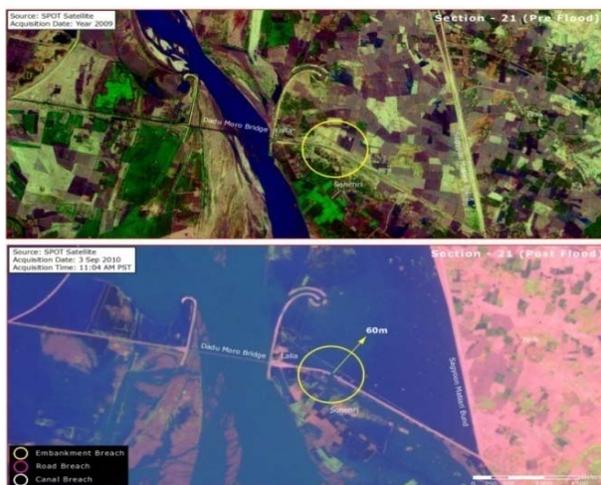
Figure 1.3 Dadu-Moro Road Breach, Sindh

Destruction of infrastructure creates a major hurdle in evacuation and rehabilitation especially due to the roads getting damaged. Figure 1.3 shows a 60 meter breach which occurred on Dadu-Moro road embankment on Indus river (links National Highway N-5 to Indus Highway N-55) produced a major infrastructure loss as it disconnected the residents of left and right bank of River Indus in this region.

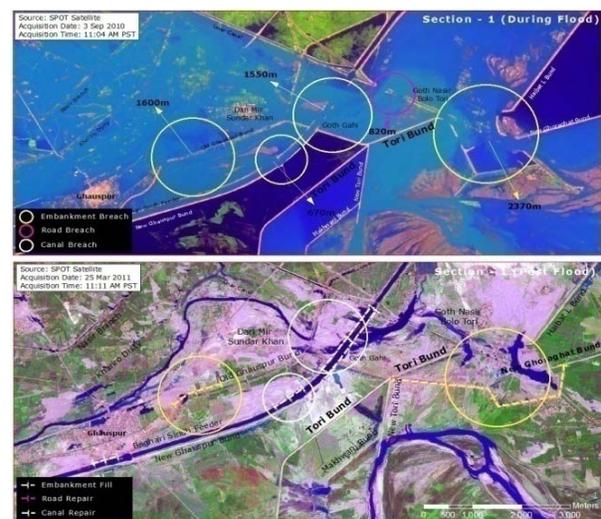
Figure 2.1 Rehabilitation of Tori Breach, Sindh

The Tori breach in Sindh and LMB in the Punjab were filled on urgent basis since these had caused major destruction over large areas. Figure 2.1 shows the rehabilitation of Tori embankment breach. It was quite difficult to repair the old breach, so new parallel embankment was constructed to fill the breached area of Tori. Other consequent breaches of Tori (Old Ghauspur bund and the

embankments of Beghari Sindh Feeder) were also rehabilitated as shown in Figure 2.1.

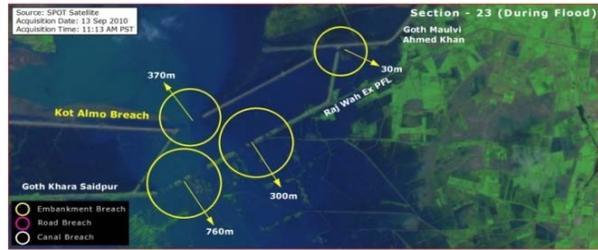
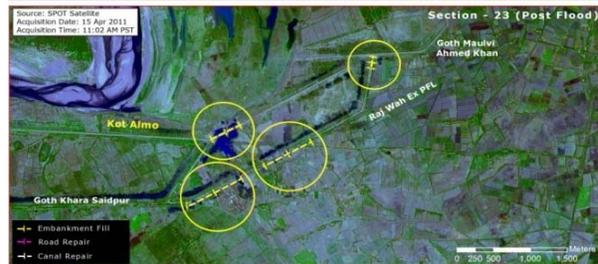
Figure 2.2 Kot Al'mo breach, District Thatta, Sindh

Kot Almo Bund breach in district Thatta also destroyed a large area of agricultural belt of lower Sindh. An important city of Sujawal was seriously affected by flood water which rushed from the Kot Almo bund. These breaches were filled on priority bases as shown in Fig 2.2. It is to be noted that two defense lines of protective embankments are present. But the water exerted immense pressure on the embankments so that both the defense lines broke and water rushed through. Later on, both the embankments were rehabilitated.

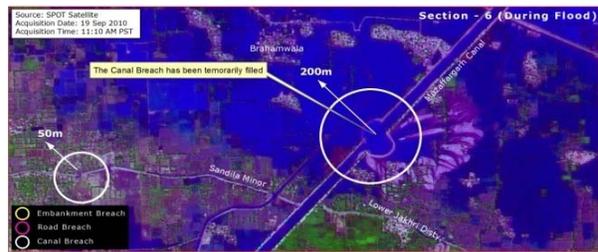
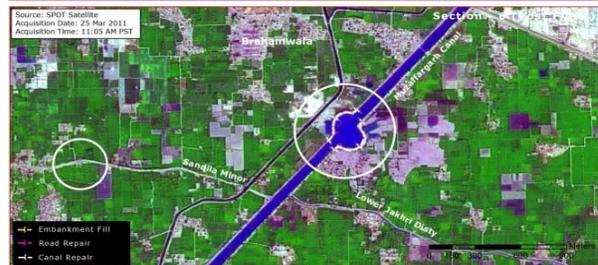
Figure 2.3 Filling of Muzaffargarh Canal Breach, Punjab

Some of the breaches which are repaired on priority basis not during flood are renovated up to the standards and that the width of the protective embankments can not be maintained. Some of the breaches are temporarily filled by creating a curved structure. Such filling are considered as partially repaired breaches. These bunds are then required to be redone in the most professional manner to maintain the next flood. Figure 2.3 shows such partial filling of Muzaffargarh canal breach, district Muzaffargarh in Punjab.
